OAKES PUBLIC SCHOOL:

FACILITY ASSESSMENT RESULTS

Board Meeting
July 6, 2023

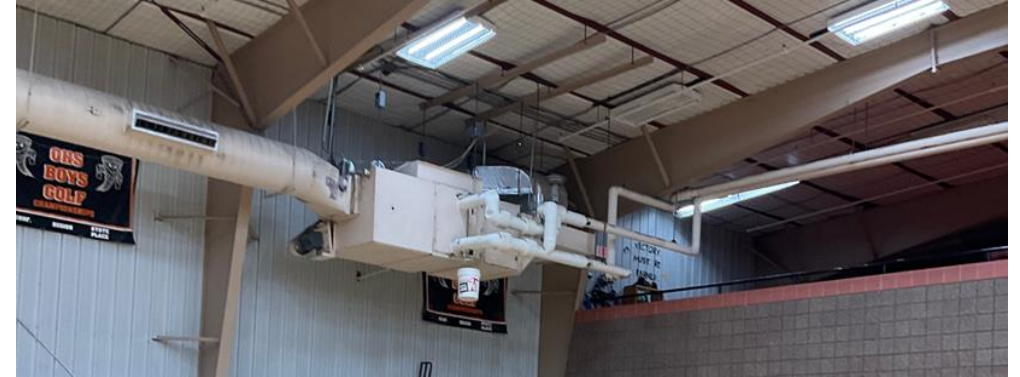
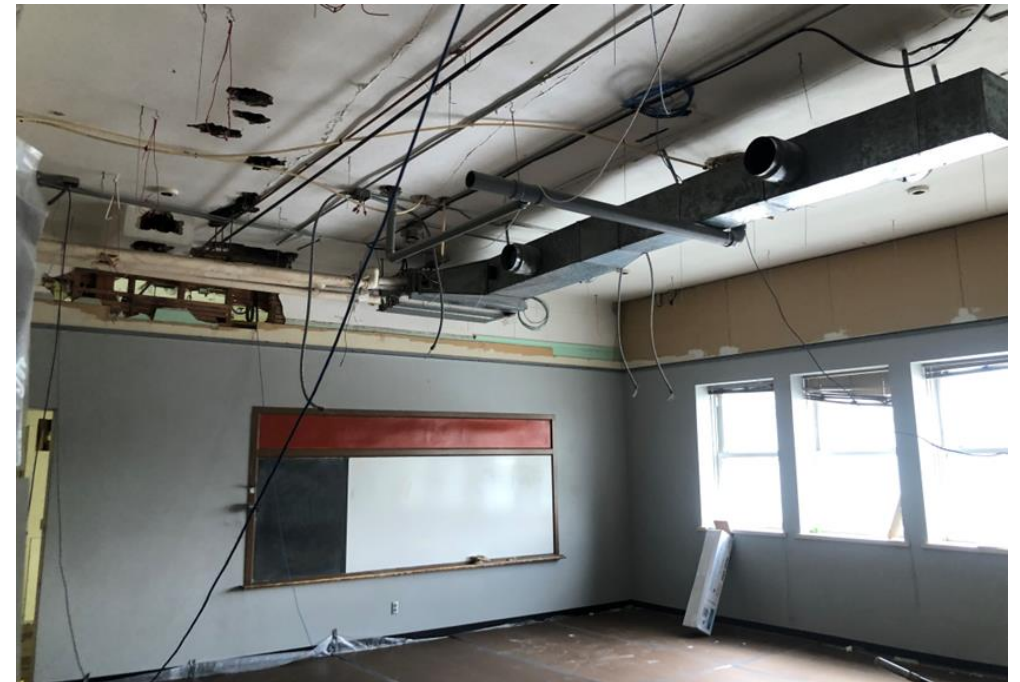
HS HVAC System / IAQ

- Two pipe hot water and chilled water system with multiple fan coil units serving each zone
- Chiller system is beyond its life expectancy and is currently not working
- Boiler system has an electric hot water boiler with a fuel oil boiler back-up. Existing electric boiler installed in 2006 is undersized. Fuel oil boiler is beyond its life expectancy
- Air handler units (2) in 1982 Gym are beyond their life expectancy
- Fan coil units in classrooms are beyond their life expectancy
- Make-up air unit serving fan coil units is beyond its life expectancy
- Temperature control system is inefficient and a combination of pneumatic controls and digital controls
- No fire protection in classroom areas.

- Remove existing HVAC system in HS classrooms and gymnasiums.
- Install new ducted ventilation systems to provide code compliant ventilation with hot water heat and chilled water cooling.
- Replace boiler and chiller systems with new, right sized, four pipe system. Equipment, pumps, controls and piping would be replaced with new.
- Replace pneumatic control system with new direct digital control system
- Existing ceiling would be removed and replace
- Existing lights would be either reinstalled or replaced with new
- Fire Protection would be installed throughout HS classroom area
- Electrical panels and service would be updated as needed

Budget Estimate: = \$11,906,500

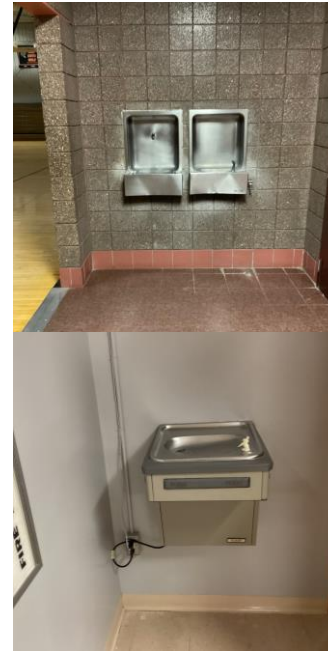
HS Plumbing System – ADA Compliance

- Student restrooms on 3rd floor are not ADA compliant
- Staff restrooms are located in stairwells and are not ADA compliant
- Men's and Women's locker room toilets between gyms is not ADA compliant.
- Drinking fountains are not ADA compliant in HS classroom areas

- Renovate 3rd floor restrooms to be ADA compliant
- Relocate existing staff restrooms to an ADA compliant location
- Renovate restrooms in locker rooms to be ADA compliant
- Install ADA drinking fountains with bottle fillers

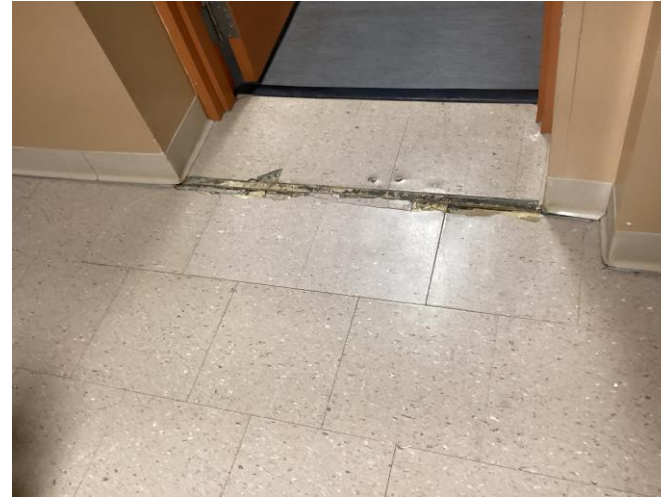
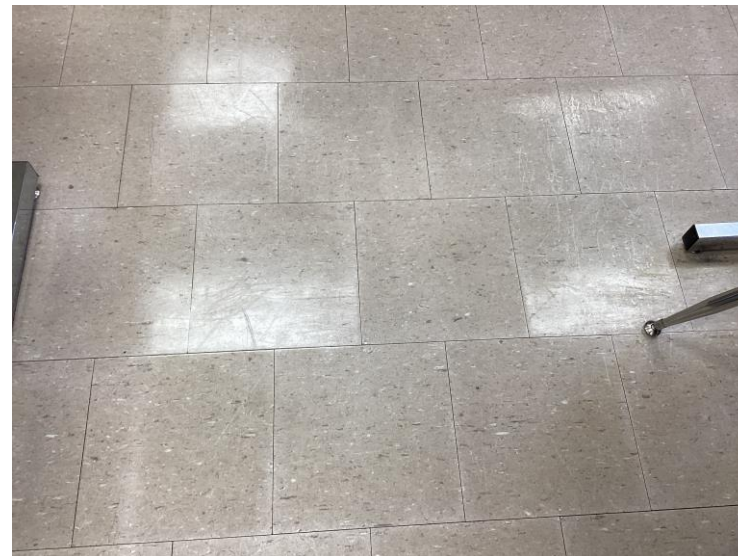
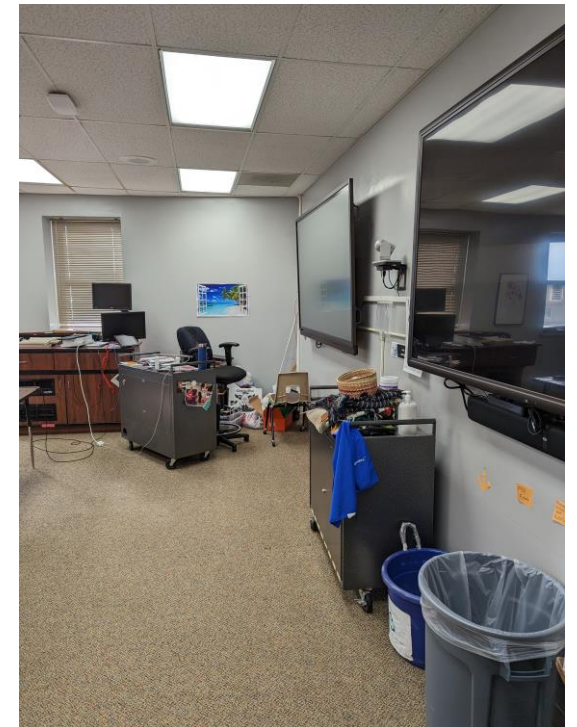
HS Interior Surfaces – Flooring

- Carpet: 2,800 SF in poor condition
- VCT Tile: 9,800 SF in poor condition

- Replace carpet with carpet squares
- Replace VCT tiles with new VCT tiles

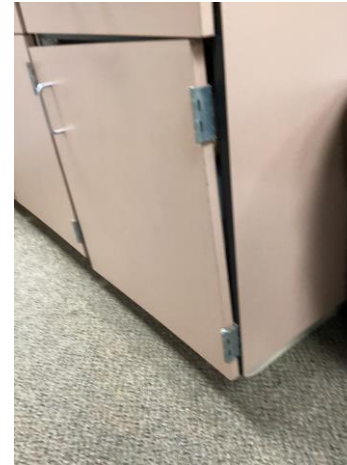
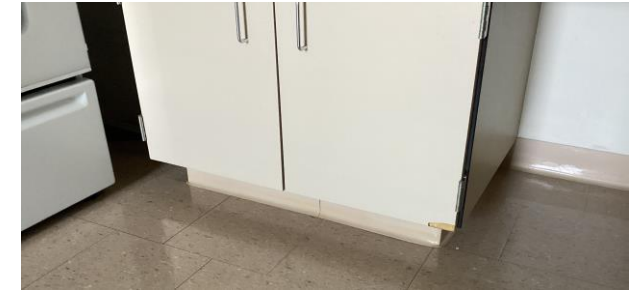
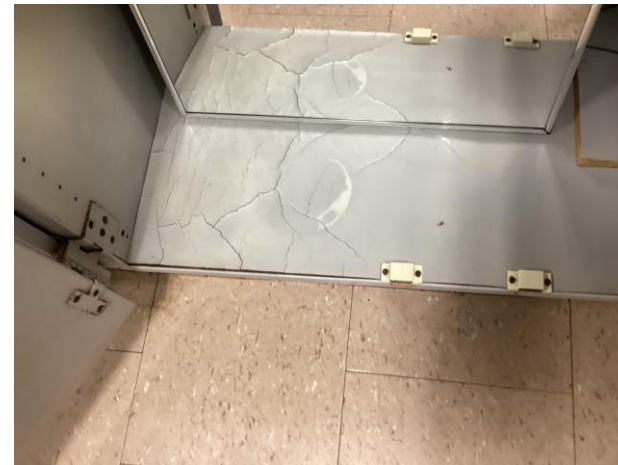
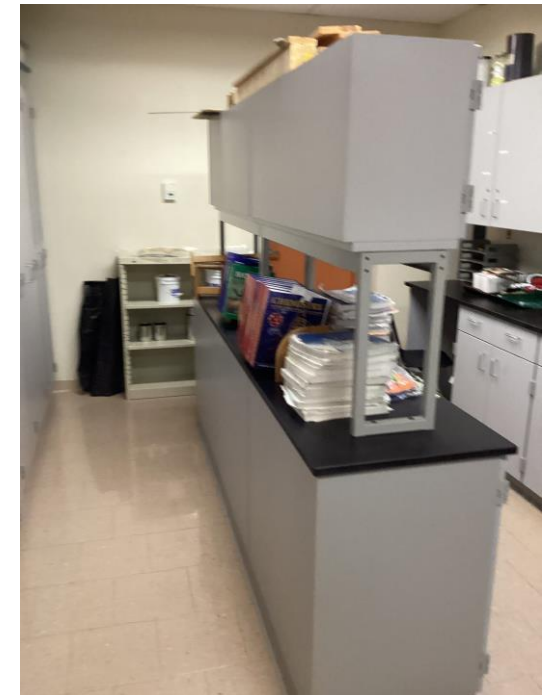
HS Interior Surfaces – Casework

- High school counters/ cabinetry are aged and should plan for replacement
- Casework has chips and hinges pulled loose

- Replace existing upper and lower cabinets, counters and sinks in existing locations
- Does not include lab counters or sinks in science area renovations

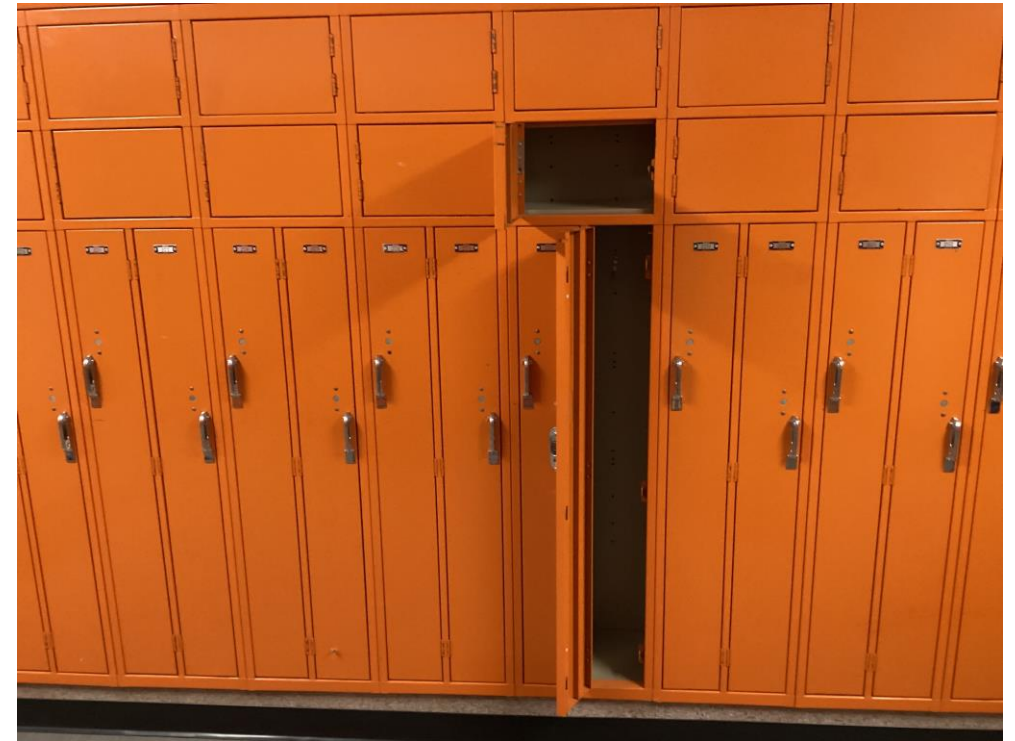
HS Building Hardware and Equipment – Student Lockers

- Lockers are small and not usable

- Replace student lockers in High school with size appropriate lockers

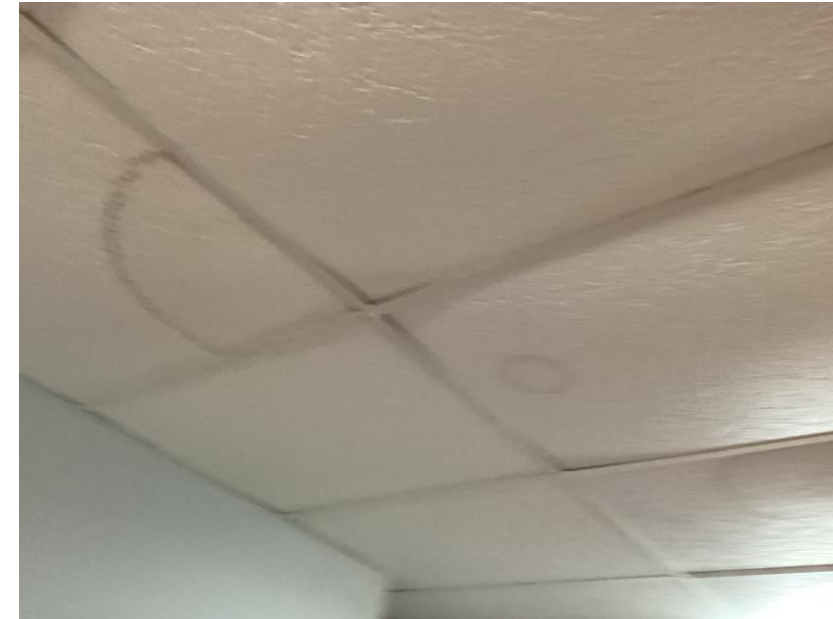
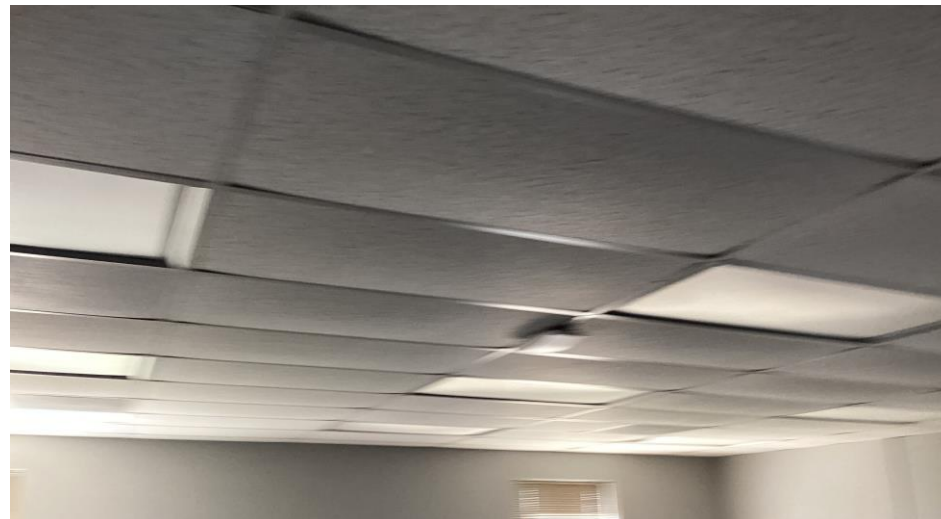
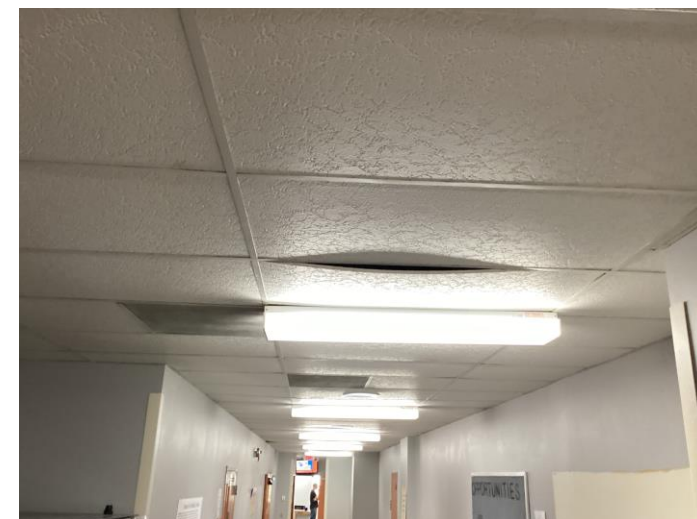
HS Interior Surfaces –Ceilings

- Many 2x4 ACT ceiling tiles are drooping or broken
- 20,200 sq ft of ACT ceiling in poor condition

- Replace ACT with 2x2 ACT ceiling tile and grid
- Install new HVAC diffusers and adjust electrical as needed
- Existing lights would be reinstalled

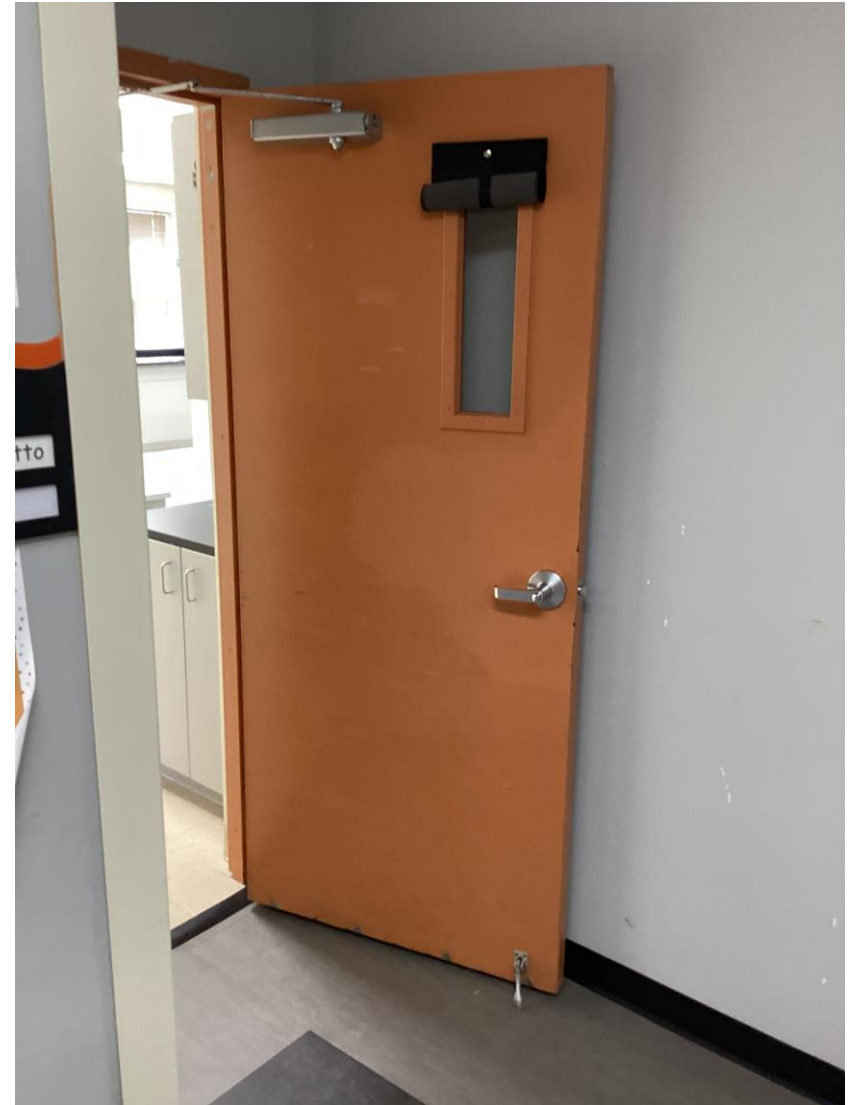
HS Building Hardware and Equipment – Interior Doors

- Classroom doors in poor condition
- Door hardware outdated

- Replace doors and frames with new door and frame (56 total)
- Update hardware on doors

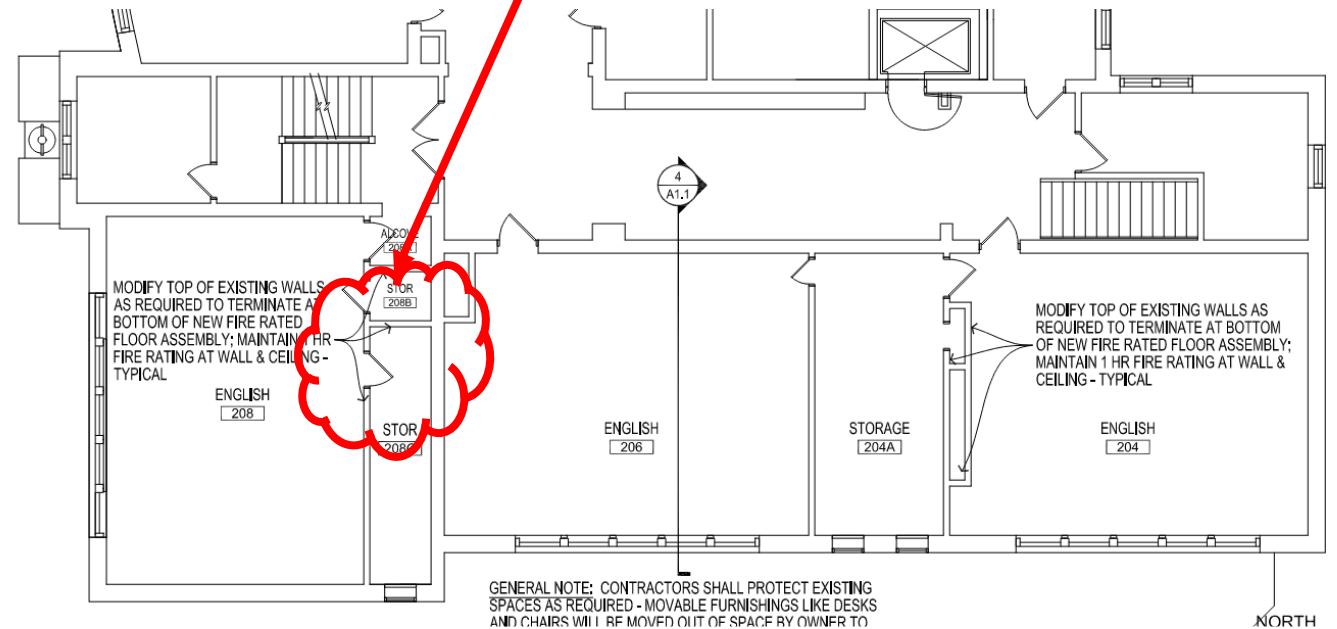
- Storage room wall below 3rd floor science room is cracked and appears to be bowing

- Investigate and repair wall during current science room flooring improvement project

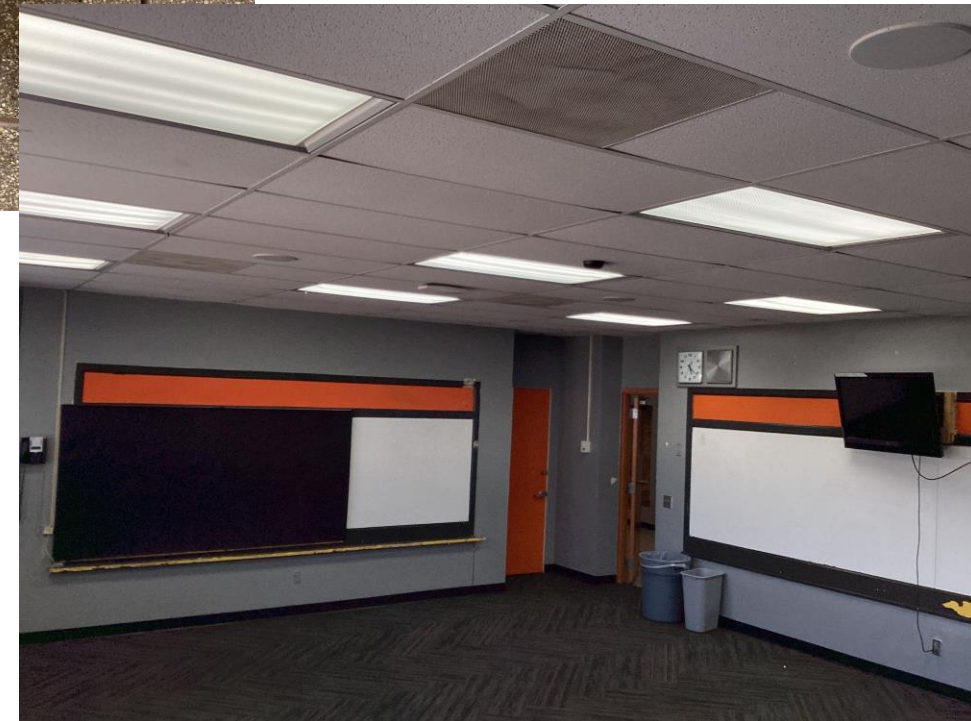
HS Electrical – Needs

- Manual light switches, no occupancy sensors or automatic lighting controls for North gym
- Manual light switches, no occupancy sensors or automatic lighting controls in classrooms
- Retrofitted LED lights throughout

- Provide lighting controls for North gym and classrooms
- Existing lights to remain

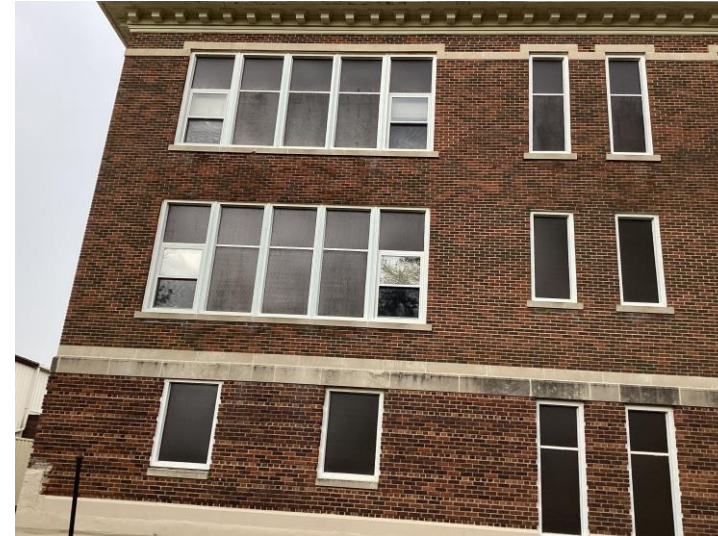
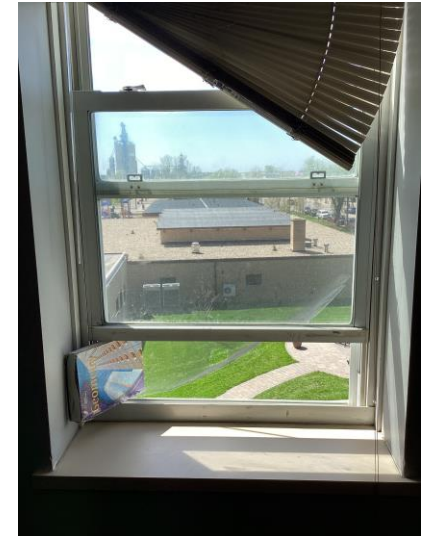
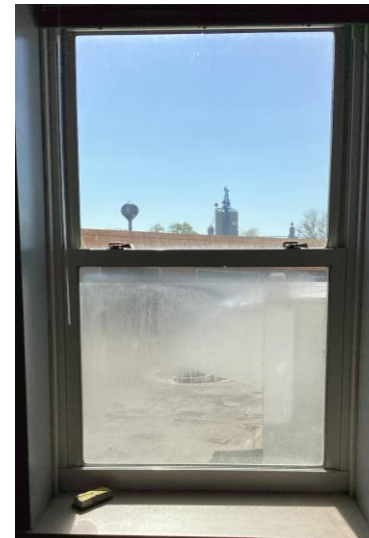
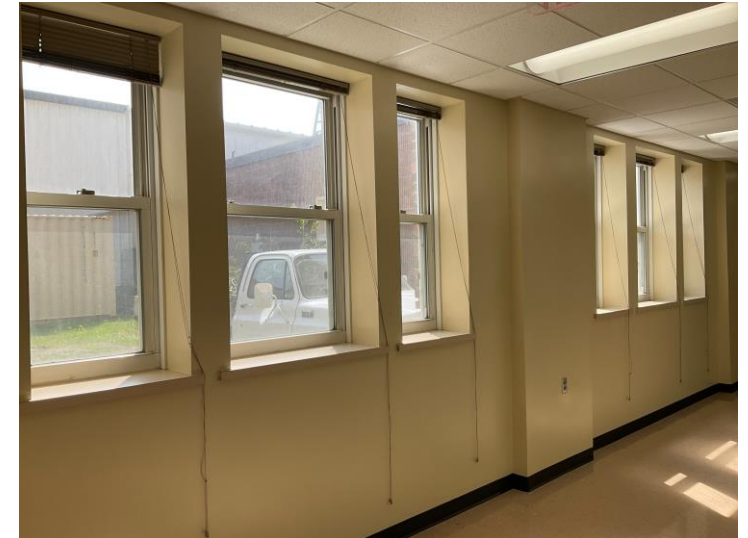
HS Building Envelope - Windows

- Windows are in poor condition and are in need replacing
 - Some windows do not stay open and are dangerous
 - Windows are inefficient
 - Some windows have been infilled with metal paneling

- Replace windows and metal infill with new energy efficient double pane windows (non-operable windows)

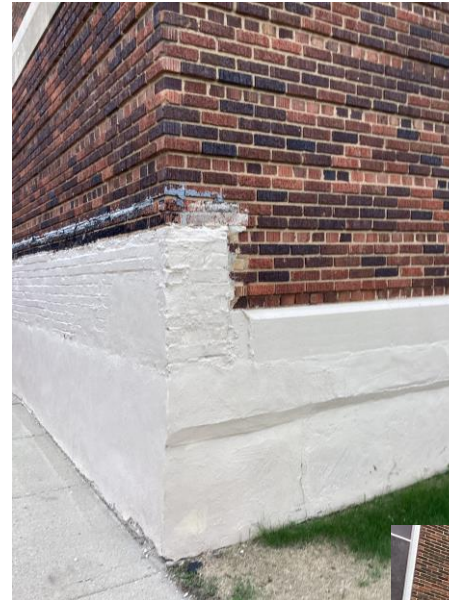
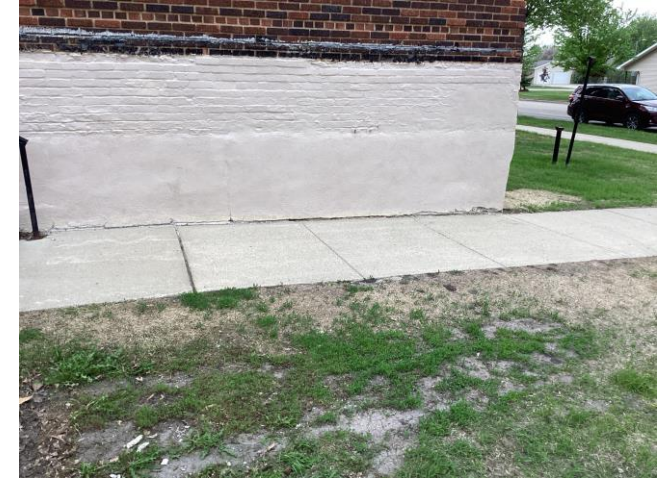
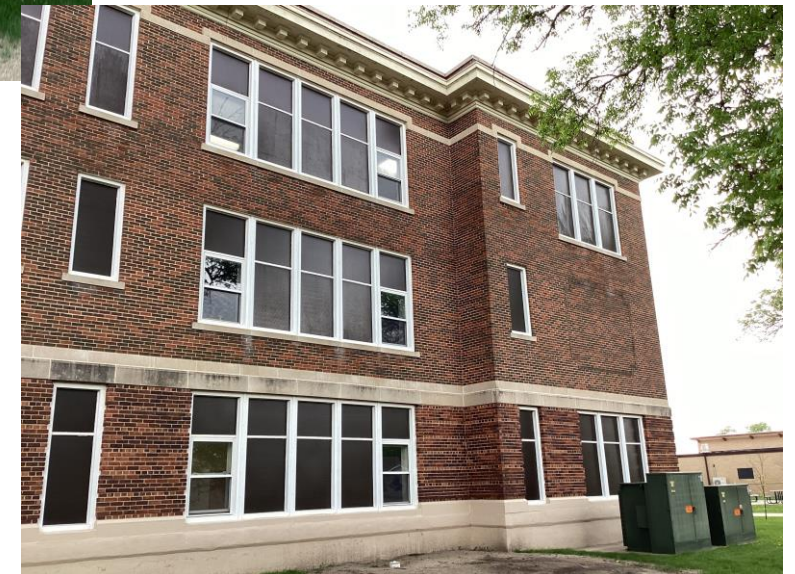
HS Building Envelope - Tuckpointing

- Tuckpointing needs throughout
- Deteriorated caulking around windows and at expansion joints
- Damaged bricks

- Perform tuckpointing, replace damaged bricks and replace caulking at expansion joints and around windows

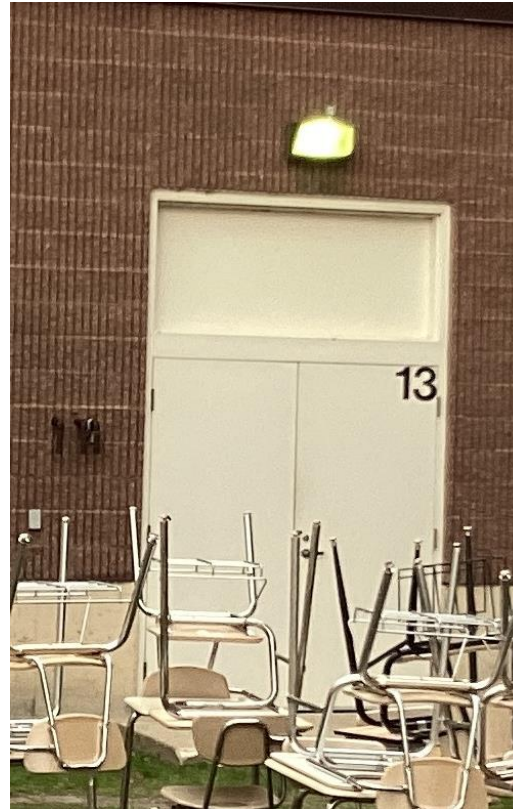
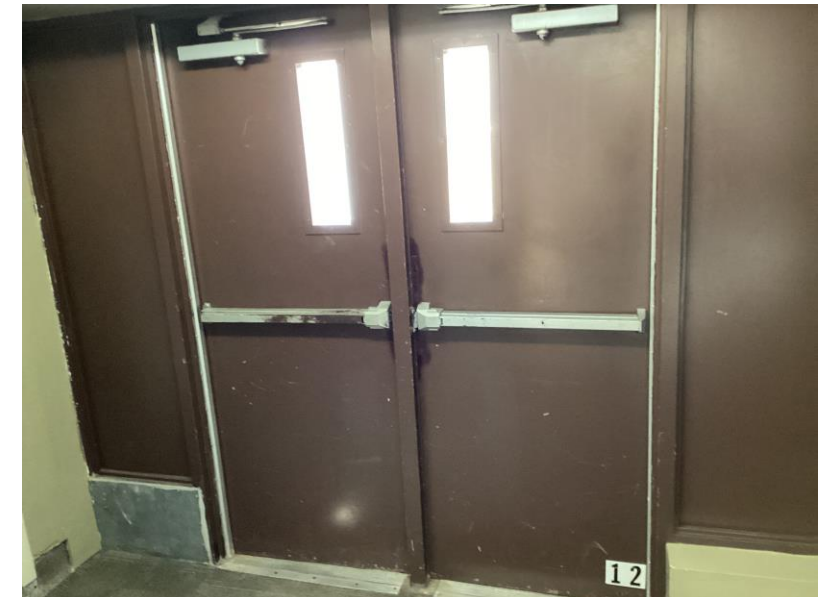
HS Building Envelope –Exterior Doors

- Door 12 and 13 are in poor condition and should be replaced

- Replace the doors with new exterior metal doors and hardware

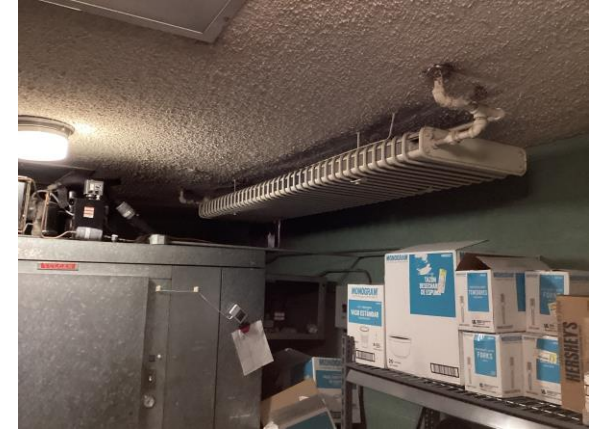
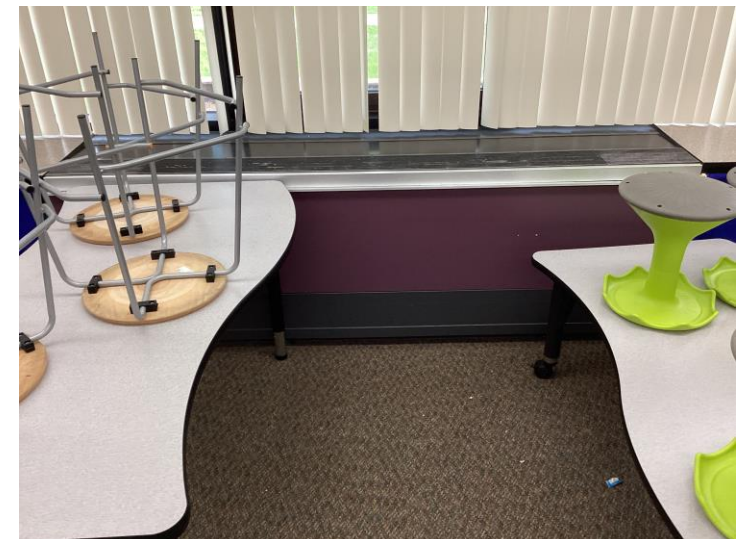
ES HVAC System / IAQ

- Unit ventilators provide heating and ventilation in classrooms. These units are beyond their life expectancy, inefficient and do not provide adequate ventilation to meet today's codes.
- Baseboard radiant heat is provided in some areas.
- Ductless mini split system with several outdoor condensing units provide cooling. These units are reaching their life expectancy and should be replaced with a more efficient system.
- Boiler system has an electric hot water boiler with a fuel oil boiler back-up. Existing electric boiler is in good working order. Fuel oil boiler is beyond its life expectancy.
- Individual thermostats provide temperature control, one for heating and one for cooling. Majority of control system is pneumatic and inefficient.
- No fire protection.

- Remove existing unit ventilators and ductless split system units
- Install new ducted ventilation systems to provide code compliant ventilation with hot water heat and cooling.
- Fuel oil boiler system equipment, pumps, controls and piping would be replaced with new. (existing electric boiler may be reused if sized accurately)
- Replace pneumatic control system with new direct digital control system
- Updated systems would update ceiling and lights
- Fire Protection would be installed throughout ES classroom area
- Electrical panels and service would be updated as needed

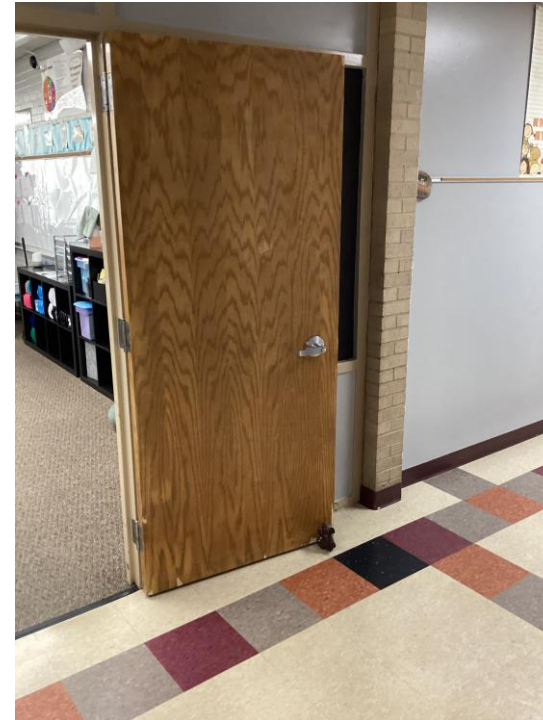
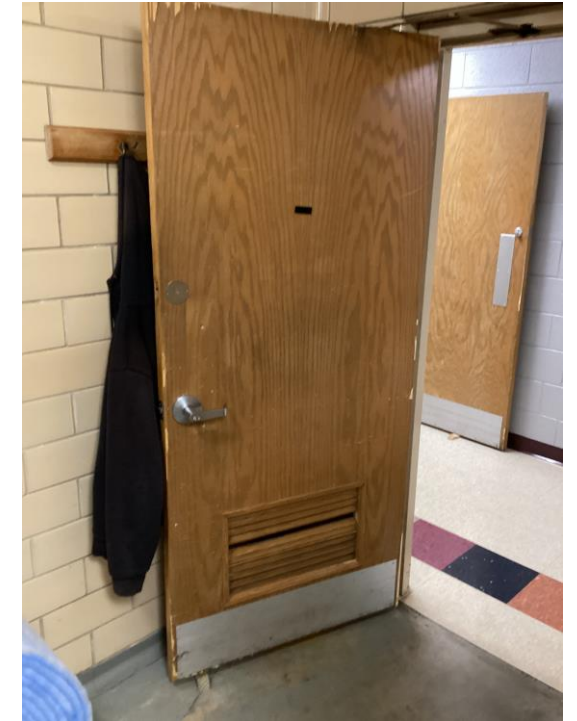
ES Building Hardware and Equipment – Classroom Doors

- Classroom doors in poor condition
- Door hardware outdated

- Replace doors and frames with new door and frame (44 total)
- Update hardware on doors

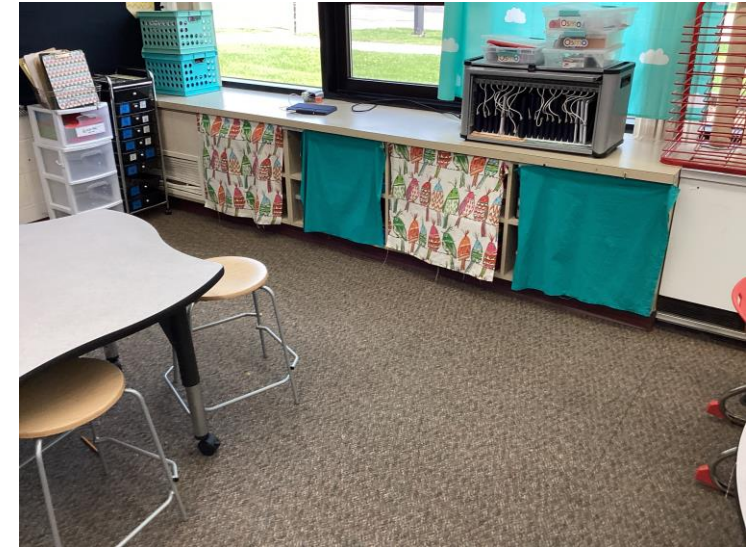
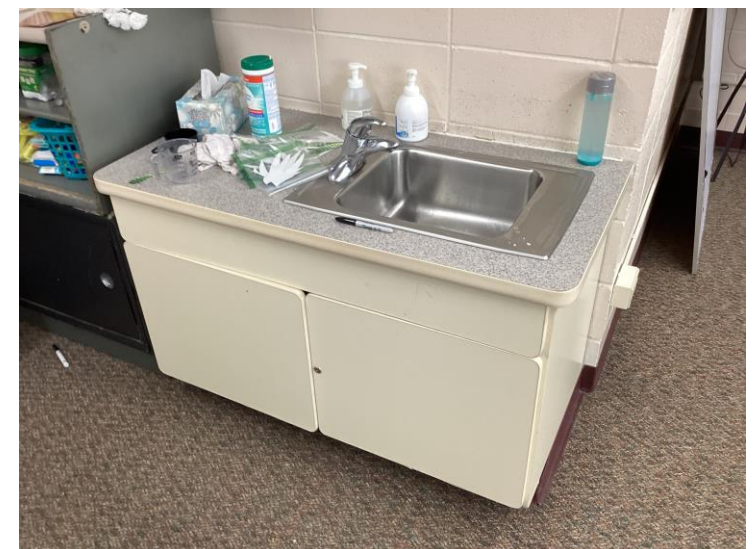
ES Interior Surfaces – Casework and Sink Replacement

- Elementary counters and cabinetry in classrooms are aged
- Sinks not ADA compliant
- Classroom sinks have individual water heaters in cabinets below. Multiple small water heaters require more maintenance and are not as efficient as a central water heater.

- Replace existing counters and cabinets with new
- Replace existing classroom sinks with ADA compliant sinks
- Reinstall existing individual water heaters at this time. Reconsider tying sinks into a central water heater if ceiling are being replaced for HVAC improvements.

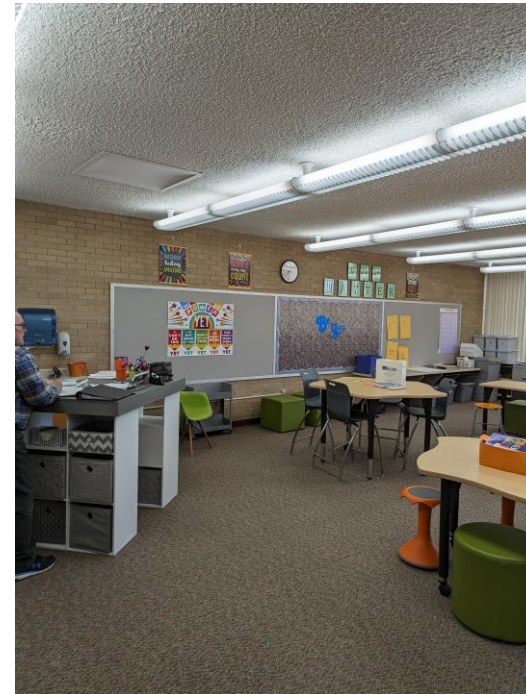
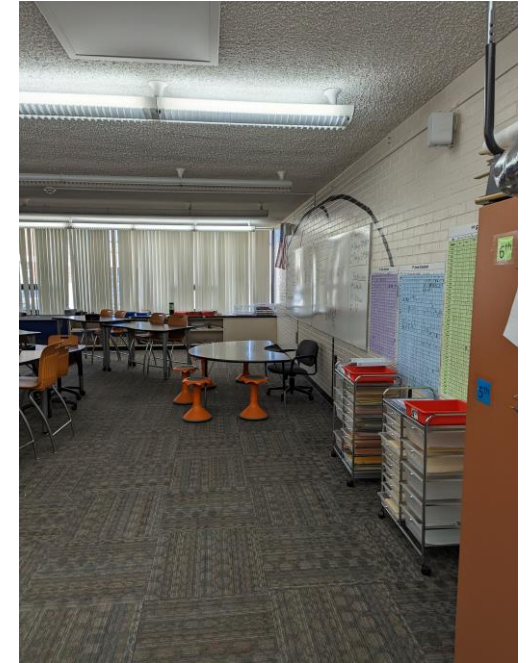
ES Electrical – Needs

- Manual light switches, no occupancy sensors or automatic lighting controls in classrooms
- Retrofitted LED lights throughout

- Install automatic lighting controls for classrooms
- Existing lights to remain

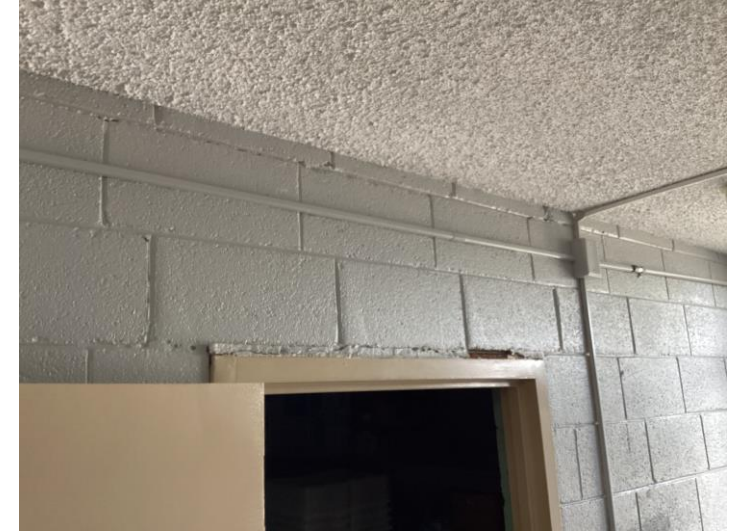
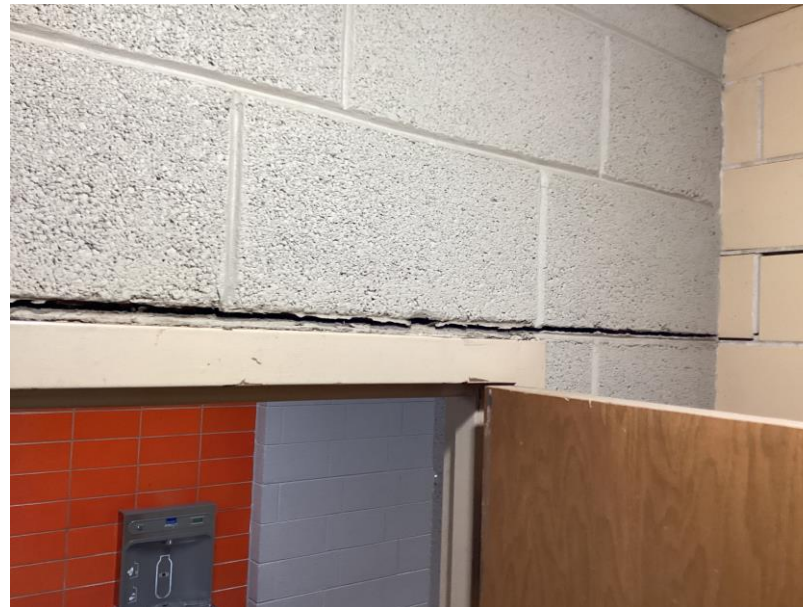
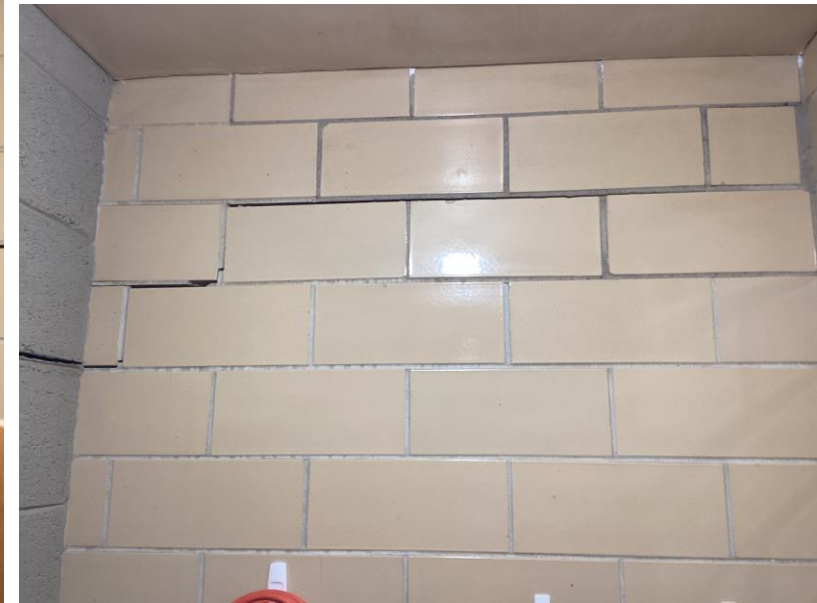
ES Interior surfaces - Cracking

- Broken mortar joints near walk in freezer and cooler room
- Broken mortar joints in a janitorial closet

- Repair caulking in both locations

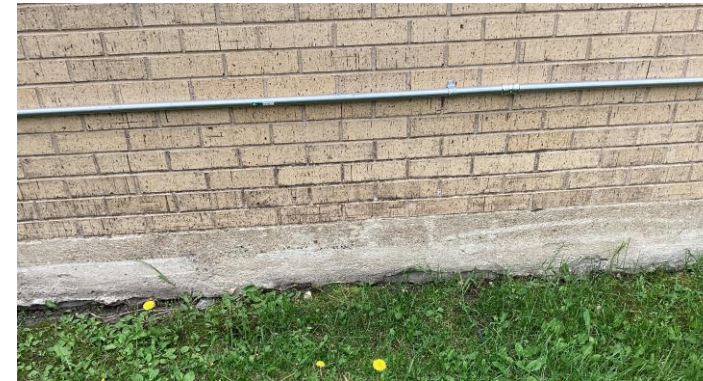
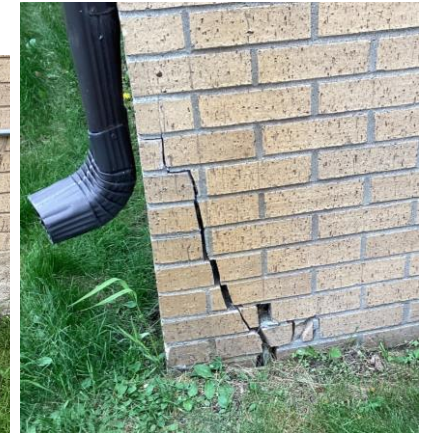
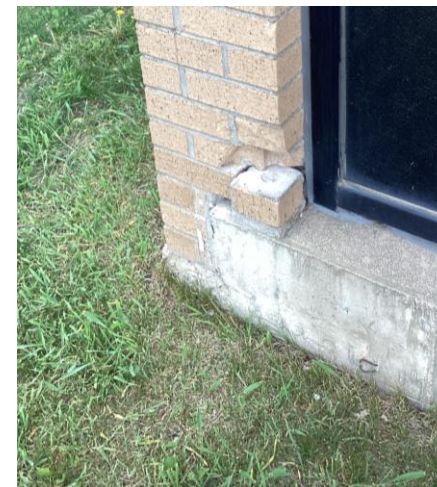
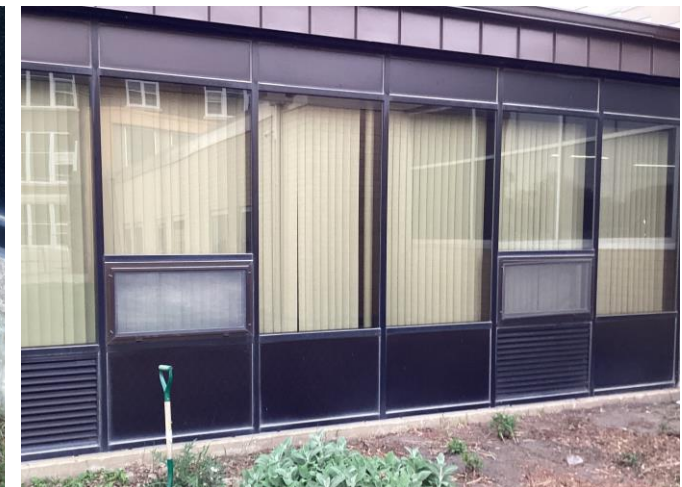
ES Building Envelope - Tuckpointing

- Tuckpointing needs throughout
- Deteriorated caulking around windows and expansion joints
- Damaged bricks

- Perform tuckpointing, replace damaged bricks and replace caulking at expansion joints and around windows

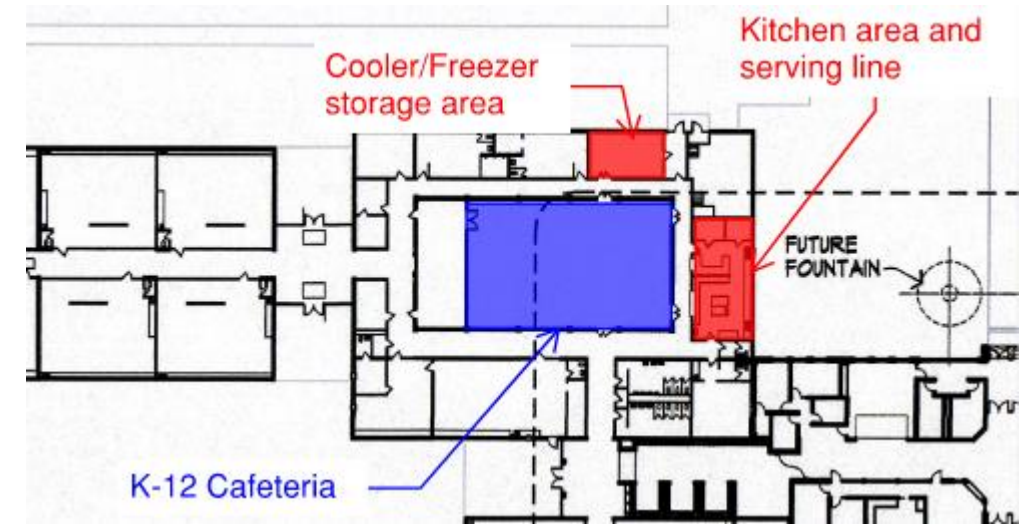
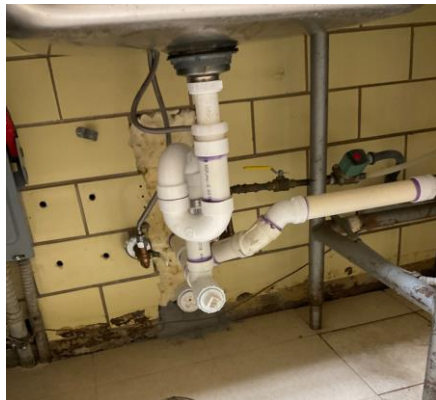
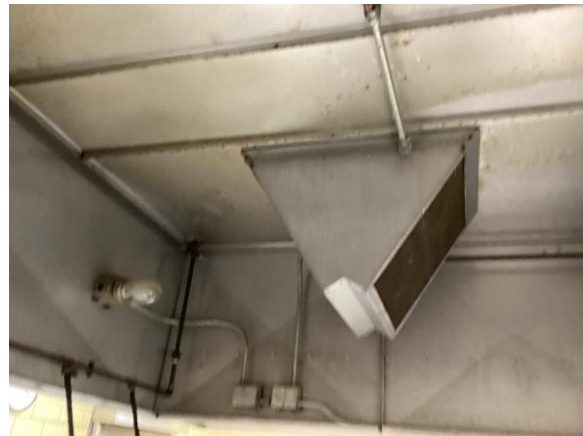
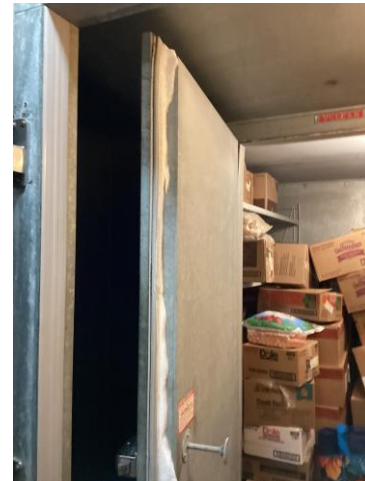
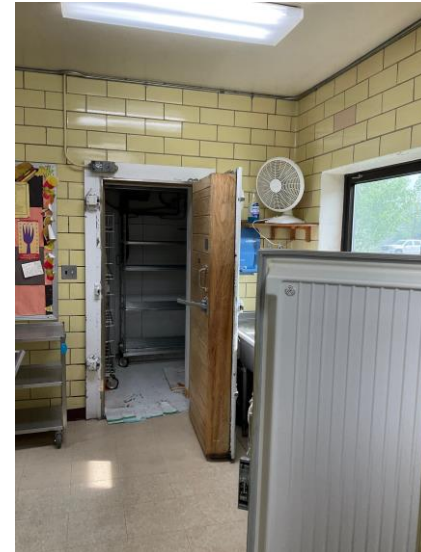
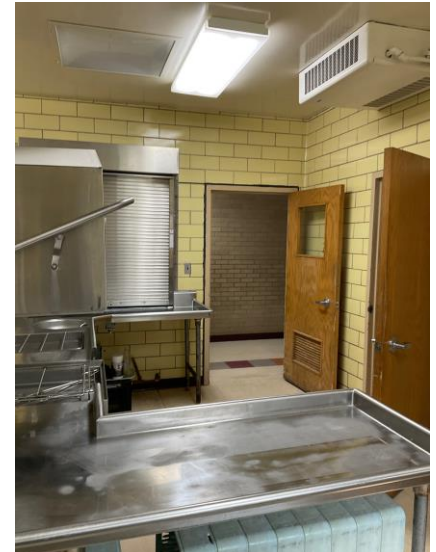
District Wide - Kitchen Renovation and Expansion

- Kitchen is undersized and interior finishes need replacement
- Kitchen is lacking a make up air system
- Freezer/Cooler is near end-of-life expectancy and storage area is undersized
- Freezer in kitchen prep area is original and in need of replacement
- Serving line is crowded and separate from cafeteria

- Remodel and expand kitchen area
- Open wall into cafeteria and create new serving lines with separate dishwashing line
- Provide new kitchen equipment
- Install new cooler/freezers and expand storage area

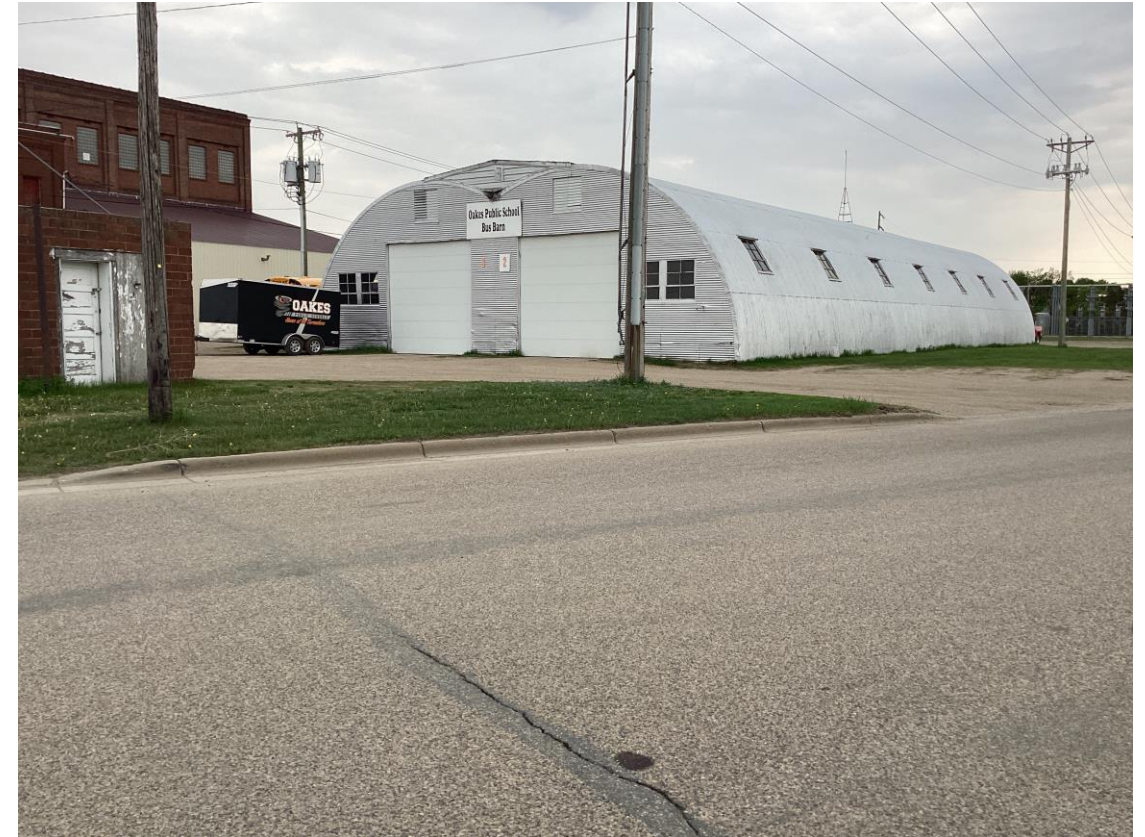
District Wide Site Projects – Bus Garage

- Old ag building that was converted into the bus garage
- Inefficient building
- Building layout and structure make bus access into building challenging

- Replace with a new building that meets the district needs
- Two heated work bays
- Cold storage building for 12 buses

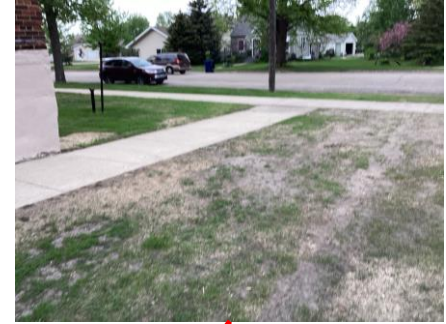
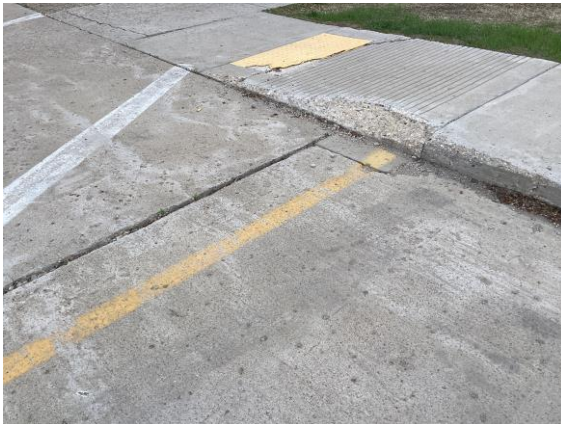
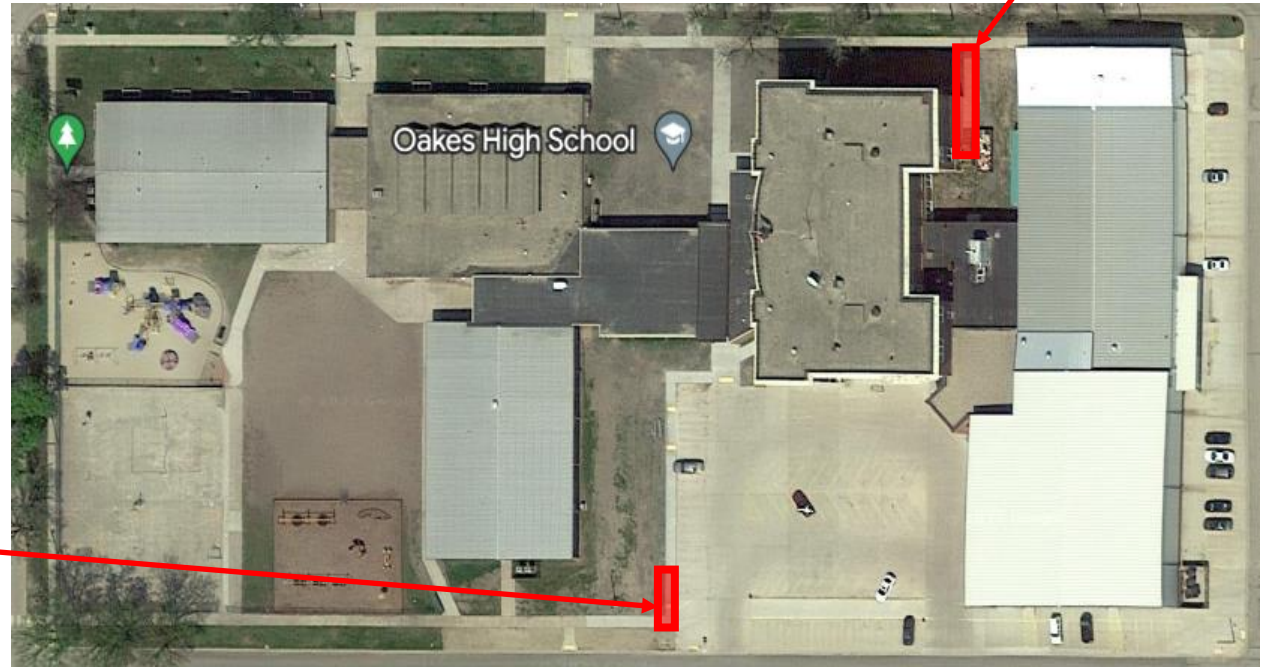
District wide Site Projects – Sidewalks

- Areas of the sidewalk are deteriorated
- Walk areas are cracked and pitted

- Remove and replace most critical areas for safety.
