OAKES PUBLIC SCHOOL:

FACILITY ASSESSMENT RESULTS

Board Meeting
July 6, 2023

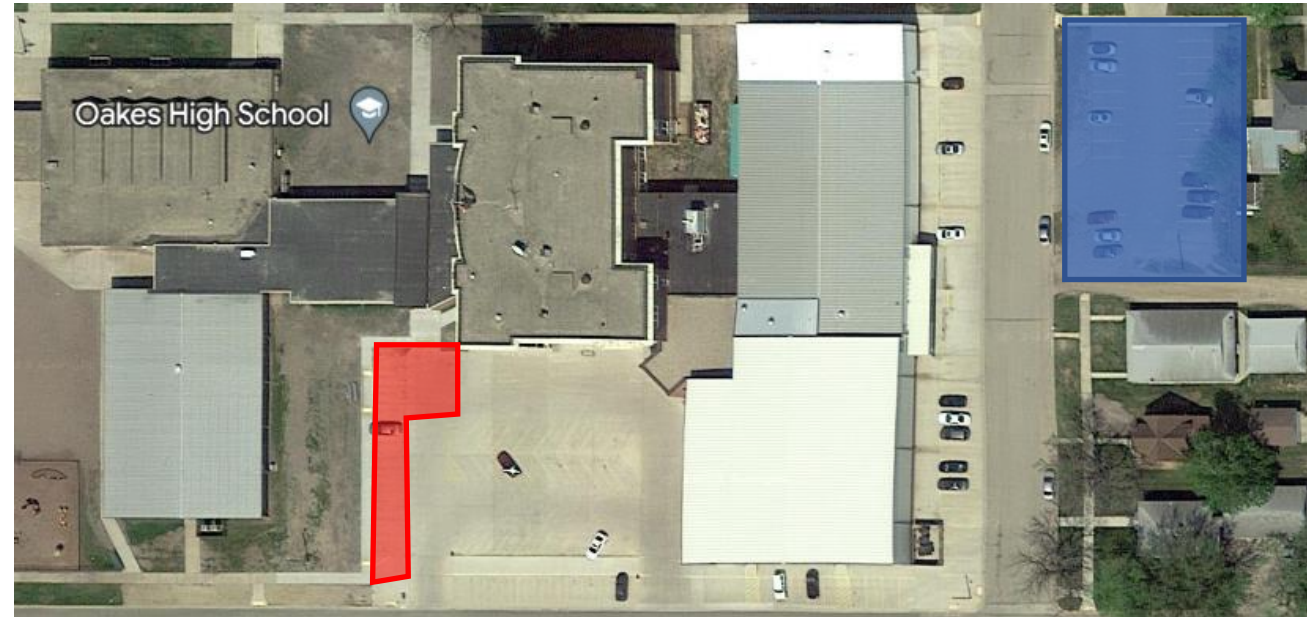
Site Projects – District wide – Parking lots

- Asphalt parking lot is need of resurfacing
- South parking lot is concrete and is showing excessive pitting in areas

- Mill and overlay existing asphalt parking lot
- Replace most critical concrete before further deterioration

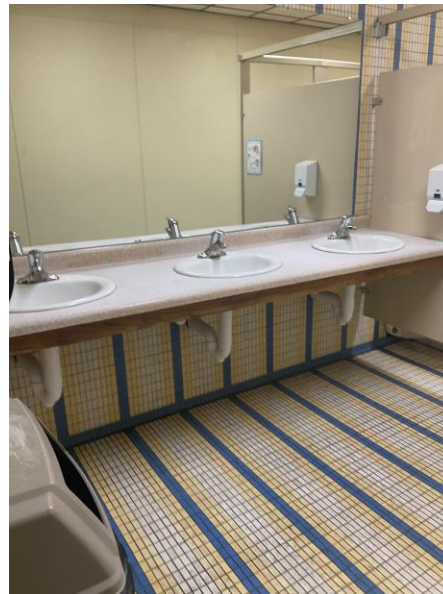
VOTECH – Plumbing – Bathroom Needs

Existing Condition:

- Men's and Women's restrooms are in poor condition and in need of replacement

- Renovate existing bathrooms into gender neutral bathrooms stall

Budget Estimate = \$553,300
